DEPARTMENT OF TRANSPORTATION**DIVISION OF ENGINEERING SERVICES**

Contract #: 04-0120F4Cty: SF/ALA Rte: 80 PM: 13.2/13.9File #: 1.28**WELDING INSPECTION REPORT****Resident Engineer:**Siegenthaler, Peter**Address:** 333 Burma Road**City:** Oakland, CA 94607**Report No:** WIR-017073**Date Inspected:** 28-Sep-2010**Project Name:** SAS Superstructure**OSM Arrival Time:** 630**Prime Contractor:** American Bridge/Fluor Enterprises, a JV**OSM Departure Time:** 1500**Contractor:** American Bridge/Fluor Enterprises, a JV**Location:** Job Site**CWI Name:** See below**CWI Present:** Yes No**Inspected CWI report:** Yes No N/A**Rod Oven in Use:** Yes No N/A**Electrode to specification:** Yes No N/A**Weld Procedures Followed:** Yes No N/A**Qualified Welders:** Yes No N/A**Verified Joint Fit-up:** Yes No N/A**Approved Drawings:** Yes No N/A**Approved WPS:** Yes No N/A**Delayed / Cancelled:** Yes No N/A**Bridge No:** 34-0006**Component:** SAS OBG**Summary of Items Observed:**

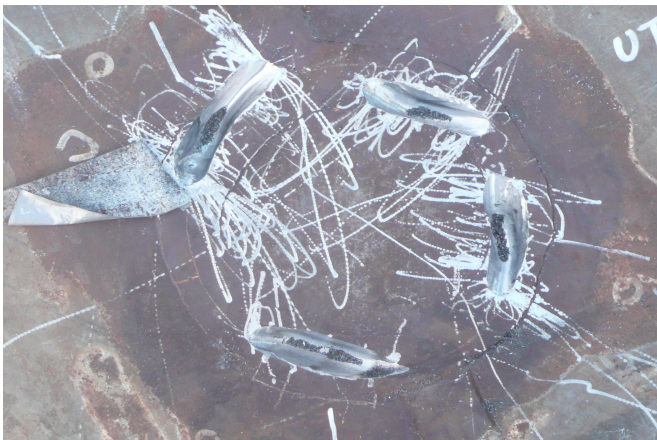
The QA Inspector performed a job walk of the East and West bound bridge decks and updated the QA NDT and production log book and chart. In addition the QA Inspector updated the QA NDT spreadsheet and production checklist for the in process production welding and repairs of the top deck plate lifting lug hole restoration. The QA Inspector noted only the top deck restoration holes in lift 1E are currently ready and are actively being repaired. No other lift are currently being repaired on this date.
